1.7.4. LENZE-BRAKE BFK458-18N (15hp & 20hp)

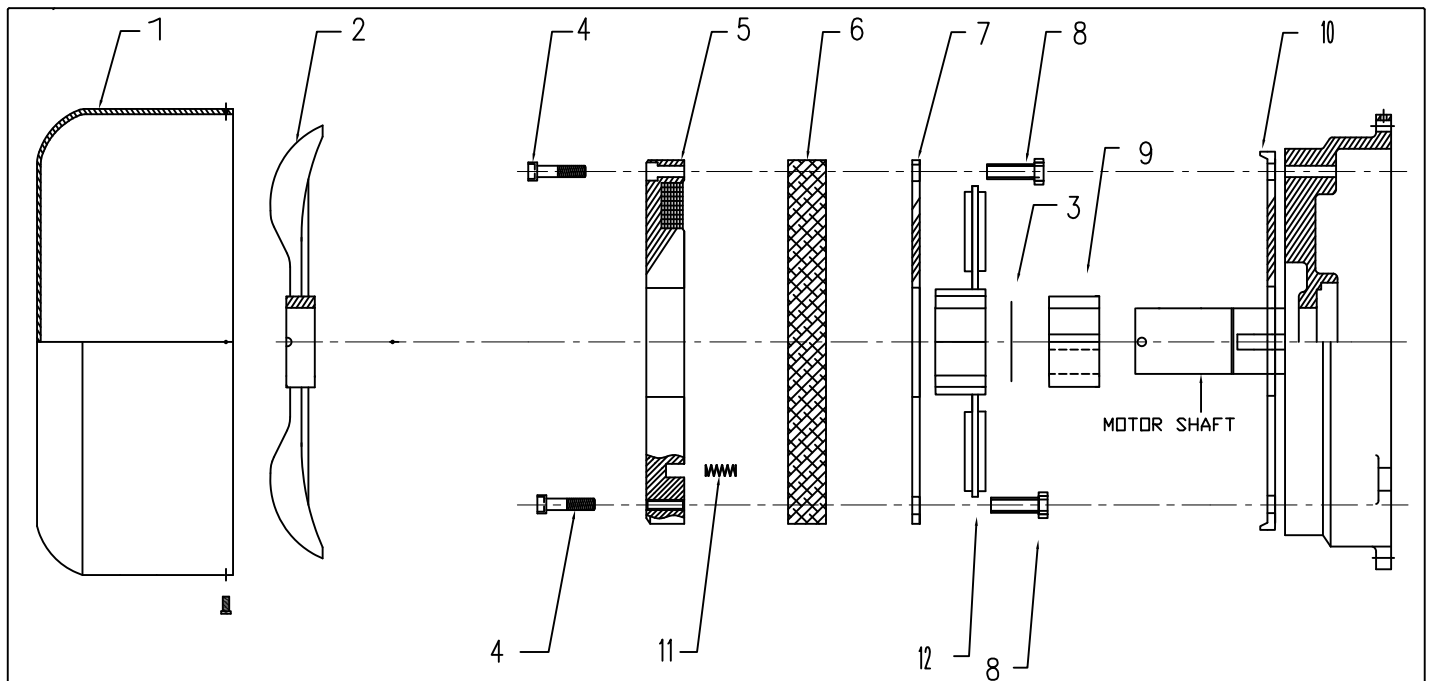
EXPLODED VIEW PART NAME:

| 1. 177-8770 FAN COVER | |
| 2. #177-8769 FAN BLADE | qty, 1 |
| 3. #177-3145 SNAP RING | qty, 1 |
| 4. #N/A ASSEMBLY BOLT | qty, 3 |
| 5. #177-8761 BRAKE COIL, | qty, 1 |
| 6. #177-8768 DUST BAND, | qty, 1 |
| 7. #N/A ARMATURE PLATE, | qty, 1 |
| 8. #N/A ADJUSTING SCREW, | qty, 6 |
| 9. #177-8765 BRAKE HUB, | qty, 1 |
| 10. #N/A FRICTION PLATE, | qty, 0 |
| 11. #N/A SPRING, qty, 9 | |
| 12. #177-8763 ROTOR, | qty, 1 |
| STARTING ROTOR THICKNESS, .5085" | |
| MIN ROTOR THICKNESS, .3937" (10mm) | |

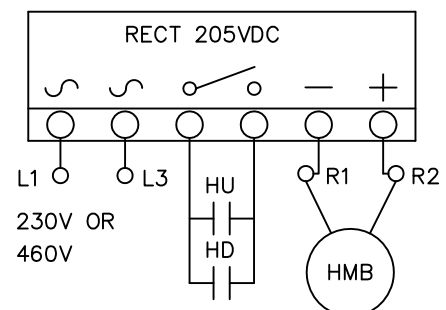
ADJUSTMENT PROCEDURE:

NOTE: AIR GAP SETTING 0.012" TO .015" (.3mm TO .4mm)
 MAXIMUM AIR GAP, .8mm

1. REMOVE THE FAN COVER.
2. REMOVE THE FAN BLADE.
3. REMOVE THE DUST BAND.
4. LOOSEN THE ASSEMBLY BOLTS
5. ADJUST THE AIR GAP BY FOLLOWING THE LISTED PROCEDURE:
 - A, MEASURE THE AIR GAP AT THREE POINTS NEAR THE ASSEMBLY BOLTS USING A FLAT FEELER GAUGE
 - B, IF THE MAXIMUM AIR GAP HAS BEEN REACH OR THE MEASUREMENT DO NOT MATCH, LOOSEN THE 6 ADJUSTING SCREWS
 - C. TIGHTEN THE 3 ASSEMBLY BOLTS EQUALLY TO THE RECOMMENDED AIR GAP. THE AIR GAP VALUE MUST BE UNIFORM IN THE SIX MEASURING POINTS.
 - D, TIGHTEN THE ADJUSTING SCREW UP TO THE POINT THEIR END SEATS ON THE BRAKE FRICTION PLATE OR MOTOR HOUSING. DO NOT TIGHTEN EXCESSIVELY. RETIGHTEN THE ASSEMBLY BOLTS FIRMLY
 - E, RECHECK FINAL AIR GAP SETTINGS
6. REINSTALL THE DUST BAND.
7. REINSTALL THE FAN BLADE.
8. REINSTALL THE FAN COVER.
